An Immersion Suit Bag Is *Not* a Laundry Bag

WRONG EPIRB PART PROVES DISASTEROUS ON F/V ADRIATIC

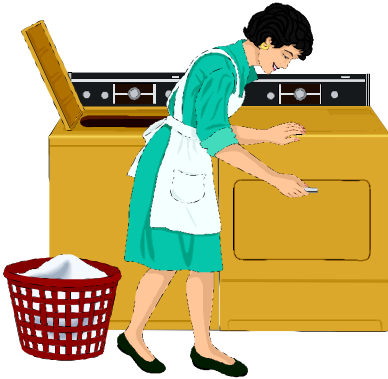
A crew member on a Southeastern Alaska vessel was told to check out his immersion suit before stowing it. He declined, saying he had checked it recently and everything was fine. Nothing else was said on the matter.

After fishing for part of the season, a drill was conducted. The crew member shook his immersion suit bag . . . and a pile of dirty laundry emerged! Someone had borrowed his immersion suit bag for use as a laundry bag.

There are two lessons to be learned from his experience. First, shake out those immersion suit bags and go over

the maintenance of that suit. Monthly drills are a good opportunity. Second, don't use immersion suit bags as laundry bags, or for any other purpose. You should **always** know that your suit is in the bag. A pile of dirty laundry is of little help in an emergency at sea. You will want something to don other than dirty socks, underwear and sweats!
